**Flood Control Project Maintenance
Levee Inspections**

Maintenance Issue Types Only, Levee Inspection Report By Mile - Spring 2018

Levee District No. 0003 (Glenn County)

Waterway	Bank	Unit Miles	Inspection Start/End	Inspector
Unit No. 01 Glenn County Sacramento River	Left	11.97	03/09/2018 03/09/2018	Bob Duffey

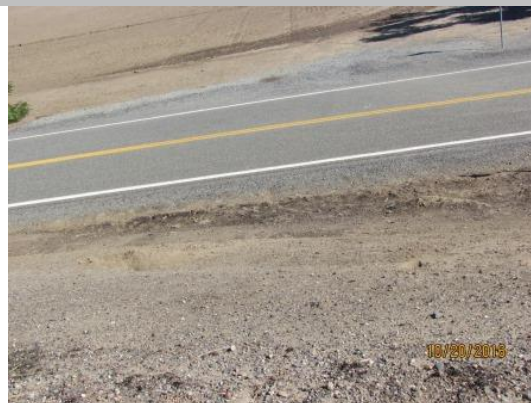
Photo 1 of 1 : SP_2018_LD0003_27_105_20180305_00068.jpg

LM Start	0.27	Rating **	M	Issue No.	105
LM End	0.27	Issue Type +	Ma	Location *	LS
Category	Earthen Levee			GPS Latitude/Longitude	
				Start	End
Item	Animal Control			39.387413 °	39.387413 °
				-121.991086 °	-121.991086 °
DWR ID	DWR_LD0003_01_f_2016_105				
Comment Code					
A3 : No rodents visible, but rodent burrows visible; need to backfill and compact or grout burrows.					
Inspector Comment

View of the rodent holes along the landside slope.

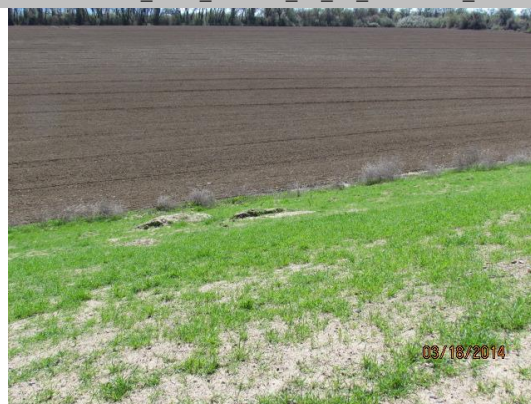
Photo 1 of 1 : SP_2018_LD0003_27_55_20180305_00036.jpg

LM Start	0.69	Rating **	M	Issue No.	55
LM End	0.69	Issue Type +	Ma	Location *	WS
Category	Earthen Levee			GPS Latitude/Longitude	
				Start	End
Item	Animal Control			39.388716 °	39.388716 °
				-121.997774 °	-121.997774 °
DWR ID	DWR_LD0003_01_s_2014_55				
Comment Code					
A1 : Exterminate rodents and backfill and compact or grout burrows.					
Inspector Comment

View of the rodent activity along the waterside slope.

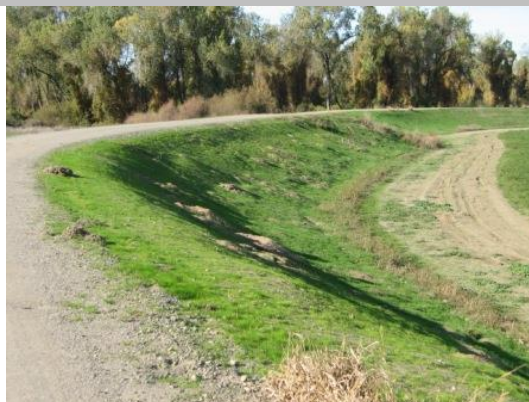
Photo 1 of 1 : SP_2018_LD0003_27_3_20180305_00001.jpg

LM Start	0.71	Rating **	U	Issue No.	3
LM End	0.77	Issue Type +	Ma	Location *	LS
Category	Earthen Levee			GPS Latitude/Longitude	
				Start	End
Item	Animal Control			39.388578 °	39.388410 °
				-121.997987 °	-121.998992 °
DWR ID	DWR_LD0003_01_s_2012_3				
Comment Code					
A3 : No rodents visible, but rodent burrows visible; need to backfill and compact or grout burrows.					
Inspector Comment

View of squirrel holes along the landside slope.

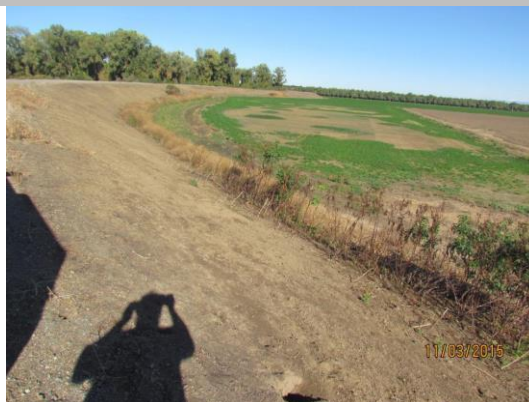
Photo 1 of 1 : SP_2018_LD0003_27_51_20180305_00033.jpg

LM Start	0.81	Rating **	U	Issue No.	51
LM End	0.91	Issue Type +	Ma	Location *	LS
Category	Earthen Levee			GPS Latitude/Longitude	
				Start	End
Item	Animal Control			39.388690 °	39.389867 °
				-121.999820 °	-122.000585 °
DWR ID	DWR_LD0003_01_f_2015_51				
Comment Code					
A3 : No rodents visible, but rodent burrows visible; need to backfill and compact or grout burrows.					
Inspector Comment

View of the rodent holes along the landside slope.

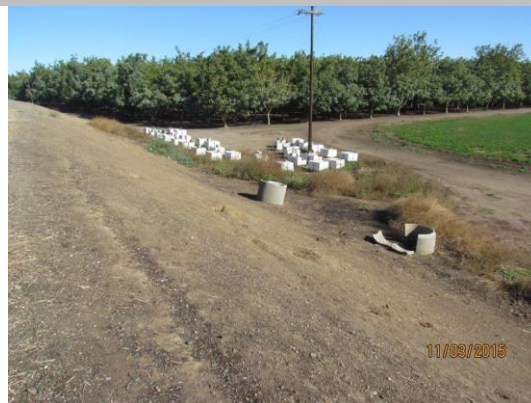
Photo 1 of 1 : SP_2018_LD0003_27_52_20180305_00034.jpg

View of the rodent holes along the landside slope.

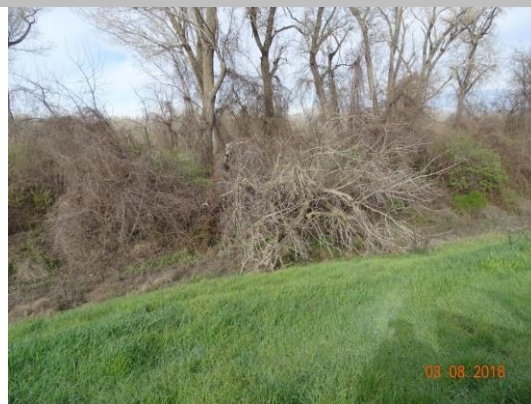
Photo 1 of 1 : SP_2018_LD0003_27_43_20180312_00108.jpg

LM Start	1.34	Rating **	M	Issue No.	43
LM End	1.34	Issue Type +	Ma	Location *	WS
Category	Earthen Levee			GPS Latitude/Longitude	
				Start	End
Item	Encroachments			39.395903 °	39.395903 °
				-122.001490 °	-122.001490 °
DWR ID	DWR_LD0003_01_s_2018_43				
Comment Code					
TR : Tree or limb					
Inspector Comment					
Remove the tree from the slope and toe.

View of the tree down on the slope and toe.

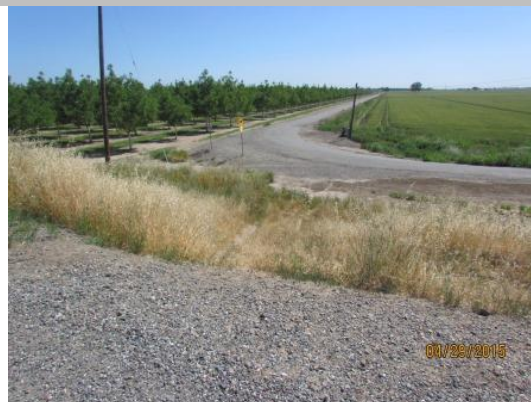
Photo 1 of 1 : SP_2018_LD0003_27_9_20180305_00006.jpg

LM Start	3.39	Rating **	M	Issue No.	9
LM End	3.39	Issue Type +	Ma	Location *	LS
Category	Earthen Levee			GPS Latitude/Longitude	
				Start	End
Item	Slope Stability			39.418382 °	39.418382 °
				-121.992480 °	-121.992480 °
DWR ID	DWR_LD0003_01_s_2012_9				
Comment Code					
S3 : Repair the levee slope damaged by vehicle traffic and prevent access where possible.					
Inspector Comment					
Repair the erosion along the landside slope and prevent vehicle access

View of the vehicle erosion along the landside slope.

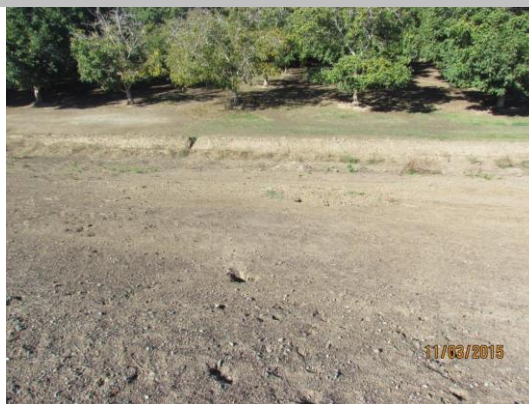
Photo 1 of 1 : SP_2018_LD0003_27_59_20180305_00038.jpg

LM Start	3.88	Rating **	M	Issue No.	59
LM End	3.88	Issue Type +	Ma	Location *	WS
Category	Earthen Levee			GPS Latitude/Longitude	
				Start	End
Item	Animal Control			39.425162 °	39.425162 °
				-121.990528 °	-121.990528 °
DWR ID	DWR_LD0003_01_f_2015_59				
Comment Code					
A3 : No rodents visible, but rodent burrows visible; need to backfill and compact or grout burrows.					
Inspector Comment

View of the rodent holes along the landside slope.

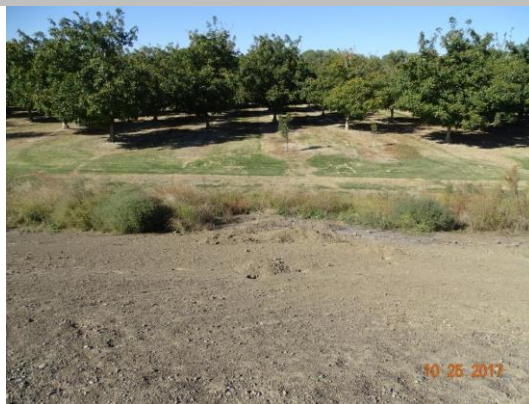
Photo 1 of 1 : SP_2018_LD0003_27_58_20180305_00037.jpg

LM Start	4.20	Rating **	U	Issue No.	58
LM End	4.20	Issue Type +	Ma	Location *	WS
Category	Earthen Levee			GPS Latitude/Longitude	
				Start	End
Item	Animal Control			39.429097 °	39.429097 °
				-121.987510 °	-121.987510 °
DWR ID	DWR_LD0003_01_f_2017_58				
Comment Code					
A3 : No rodents visible, but rodent burrows visible; need to backfill and compact or grout burrows.					
Inspector Comment					
Repair the rodent holes along the waterside slope.

View of the rodent holes along the waterside slope.

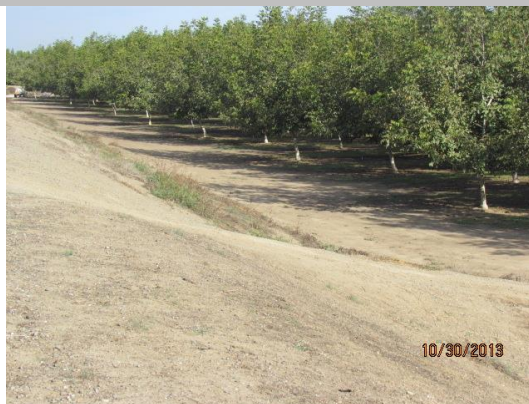
Photo 1 of 1 : SP_2018_LD0003_27_64_20180305_00043.jpg

View of the rodent activity along the landside slope.

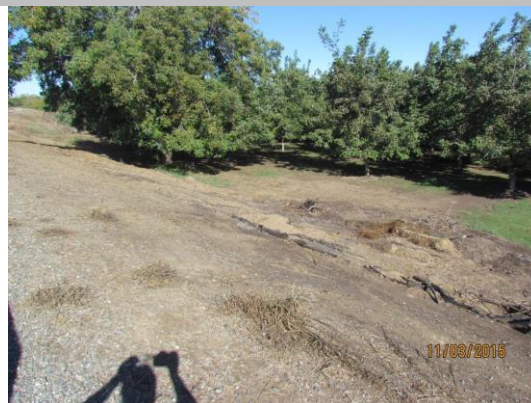
Photo 1 of 1 : SP_2018_LD0003_27_21_20180305_00014.jpg

View of the rodent holes along the landside slope.

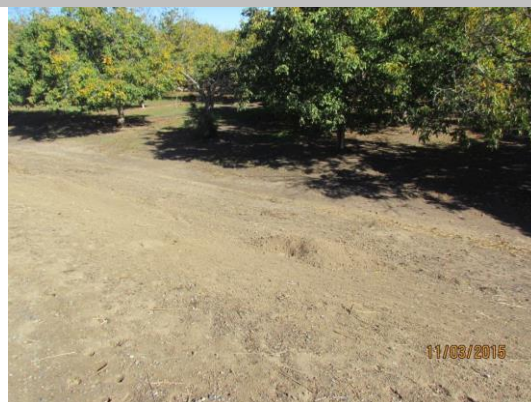
Photo 1 of 1 : SP_2018_LD0003_27_70_20180305_00048.jpg

LM Start	5.38	Rating **	U	Issue No.	70
LM End	5.39	Issue Type +	Ma	Location *	LS
Category	Earthen Levee			GPS Latitude/Longitude	
				Start	End
Item	Animal Control			39.445619 °	39.445808 °
				-121.991510 °	-121.991552 °
DWR ID	DWR_LD0003_01_f_2015_70				
Comment Code					
A3 : No rodents visible, but rodent burrows visible; need to backfill and compact or grout burrows.					
Inspector Comment

View of the rodent holes along the landside slope.

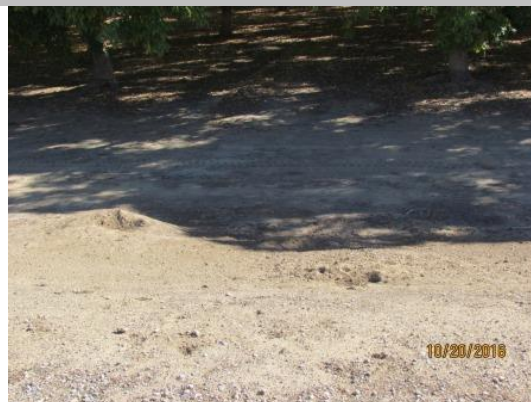
Photo 1 of 1 : SP_2018_LD0003_27_62_20180305_00041.jpg

LM Start	5.53	Rating **	U	Issue No.	62
LM End	5.62	Issue Type +	Ma	Location *	LS
Category	Earthen Levee			GPS Latitude/Longitude	
				Start	End
Item	Animal Control			39.447900 °	39.449115 °
				-121.991748 °	-121.991873 °
DWR ID	DWR_LD0003_01_f_2013_62				
Comment Code					
A3 : No rodents visible, but rodent burrows visible; need to backfill and compact or grout burrows.					
Inspector Comment

View of the rodent holes along the landside slope.

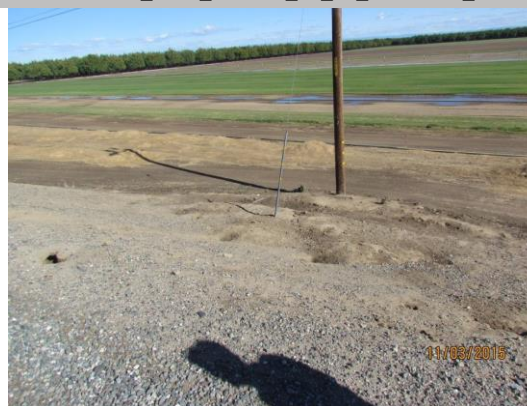
Photo 1 of 1 : SP_2018_LD0003_27_71_20180305_00049.jpg

View of the rodent holes along the landside slope.

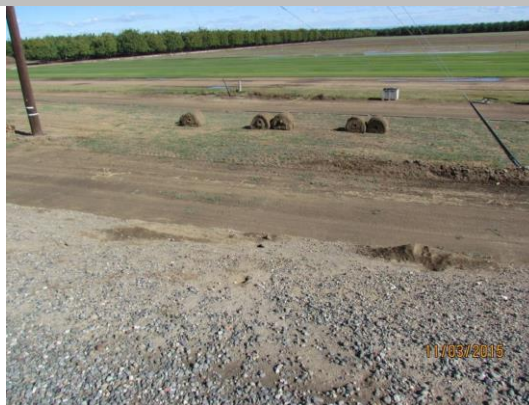
Photo 1 of 1 : SP_2018_LD0003_27_72_20180305_00050.jpg

View of the rodent holes along the landside slope.

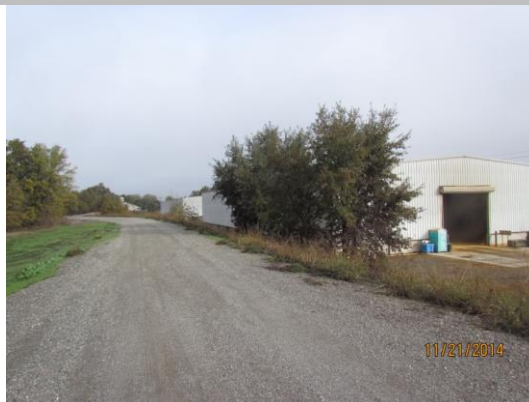
Photo 1 of 1 : SP_2018_LD0003_27_7_20180305_00005.jpg

LM Start	6.24	Rating **	M	Issue No.	7
LM End	6.38	Issue Type +	Ma	Location *	LS
Category	Earthen Levee			GPS Latitude/Longitude	
				Start	End
Item	Trim / Thin Trees			39.457968 °	39.459955 °
				-121.993712 °	-121.993512 °
DWR ID	DWR_LD0003_01_s_2012_7				
Comment Code					
T1 : Trim trees to at least five feet above ground level.					
Inspector Comment

Trim the trees 5 feet for better visibility.

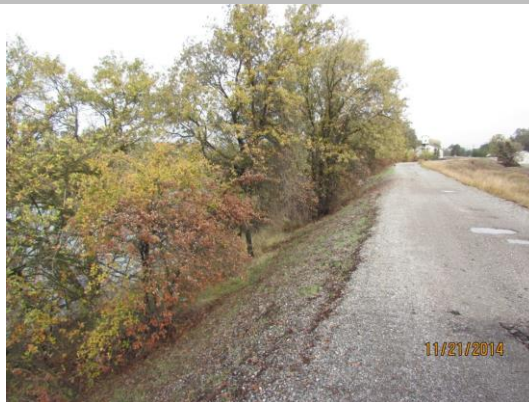
Photo 1 of 1 : SP_2018_LD0003_27_48_20180305_00025.jpg

LM Start	6.29	Rating **	M	Issue No.	48
LM End	6.38	Issue Type +	Ma	Location *	WS
Category	Earthen Levee			GPS Latitude/Longitude	
				Start	End
Item	Trim / Thin Trees			39.458587 °	39.459912 °
				-121.993777 °	-121.993592 °
DWR ID	DWR_LD0003_01_s_2012_48				
Comment Code					
T1 : Trim trees to at least five feet above ground level.					
Inspector Comment

Trim trees 5 feet above ground for better visibility.

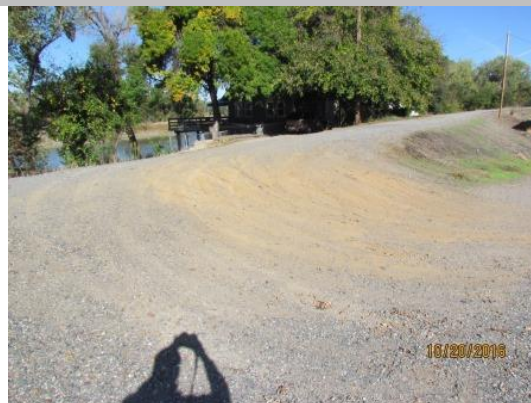
Photo 1 of 1 : SP_2018_LD0003_27_34_20180305_00018.jpg

LM Start	6.57	Rating **	M	Issue No.	34
LM End	6.57	Issue Type +	Ma	Location *	LS
Category	Earthen Levee			GPS Latitude/Longitude	
				Start	End
Item	Slope Stability			39.462505 °	39.462505 °
				-121.992698 °	-121.992698 °
DWR ID	DWR_LD0003_01_s_2012_34				
Comment Code					
S3 : Repair the levee slope damaged by vehicle traffic and prevent access where possible.					
Inspector Comment

View of slope instability caused by vehicle traffic.

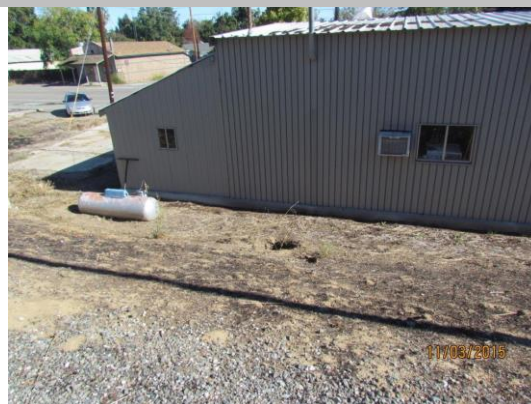
Photo 1 of 1 : SP_2018_LD0003_27_76_20180305_00053.jpg

LM Start	6.61	Rating **	U	Issue No.	76
LM End	6.61	Issue Type +	Ma	Location *	LS
Category	Earthen Levee			GPS Latitude/Longitude	
				Start	End
Item	Trim / Thin Trees			39.463185 °	39.463185 °
				-121.992657 °	-121.992657 °
DWR ID	DWR_LD0003_01_f_2015_76				
Comment Code					
T5 : Tree stumps.					
Inspector Comment					
Repair the burned out stump hole along the landside toe.

View of the burned out stump hole along the landside toe.

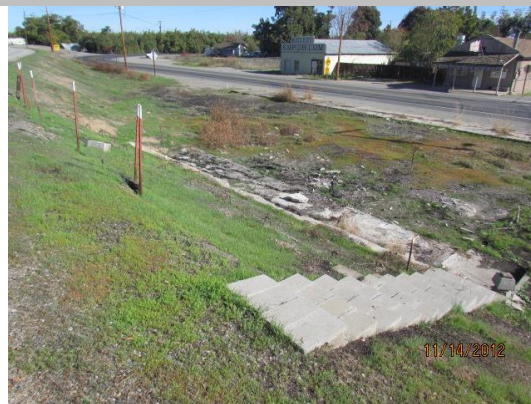
Photo 1 of 1 : SP_2018_LD0003_27_12_20180305_00010.jpg

LM Start	6.63	Rating **	M	Issue No.	12
LM End	6.63	Issue Type +	Ma	Location *	LS
Category	Earthen Levee			GPS Latitude/Longitude	
				Start	End
Item	Slope Stability			39.463366 °	39.463366 °
				-121.992586 °	-121.992586 °
DWR ID	DWR_LD0003_01_f_2012_12				
Comment Code					
S1 : Repair slope instability.					
Inspector Comment					
Building has burned down.

View of concrete stairs & foundation along the slope of the levee.

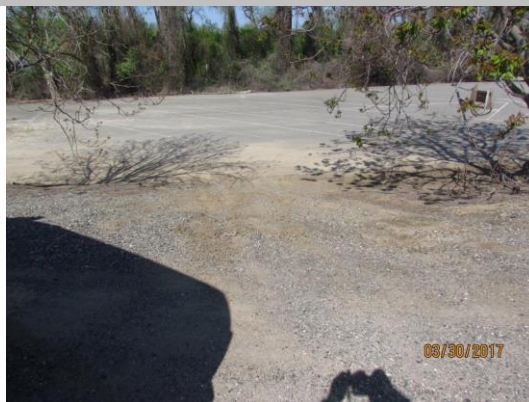
Photo 1 of 1 : SP_2018_LD0003_27_97_20180305_00063.jpg

LM Start	6.72	Rating **	M	Issue No.	97
LM End	6.72	Issue Type +	Ma	Location *	WS
Category	Earthen Levee			GPS Latitude/Longitude	
				Start	End
Item	Slope Stability			39.464653 °	39.464653 °
				-121.991789 °	-121.991789 °
DWR ID	DWR_LD0003_01_f_2016_97				
Comment Code					
S3 : Repair the levee slope damaged by vehicle traffic and prevent access where possible.					
Inspector Comment					
Repair the vehicle ruts on the waterside slope.

View of the vehicle ruts on the waterside slope.

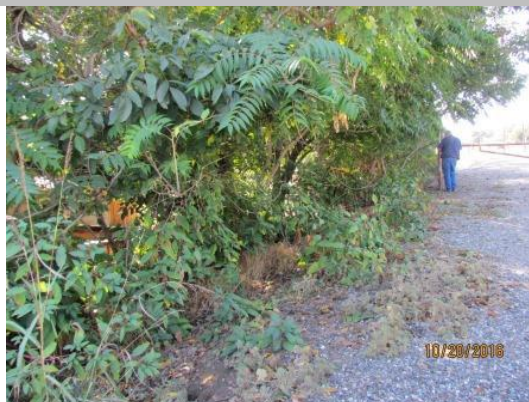
Photo 1 of 1 : SP_2018_LD0003_27_35_20180305_00019.jpg

LM Start	6.75	Rating **	M	Issue No.	35
LM End	6.75	Issue Type +	Ma	Location *	LS
Category	Earthen Levee			GPS Latitude/Longitude	
				Start	End
Item	Trim / Thin Trees			39.465013 °	39.465013 °
				-121.991455 °	-121.991455 °
DWR ID	DWR_LD0003_01_s_2012_35				
Comment Code					
T1 : Trim trees to at least five feet above ground level.					
Inspector Comment

View of the trees that are hanging over the landside slope of the levee.

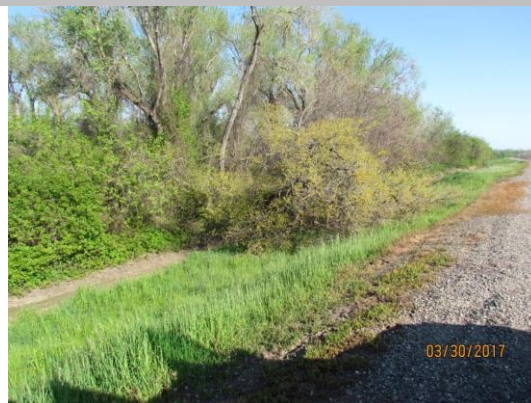
Photo 1 of 1 : SP_2018_LD0003_27_47_20180305_00024.jpg

View of the tree on the waterside slope and toe.

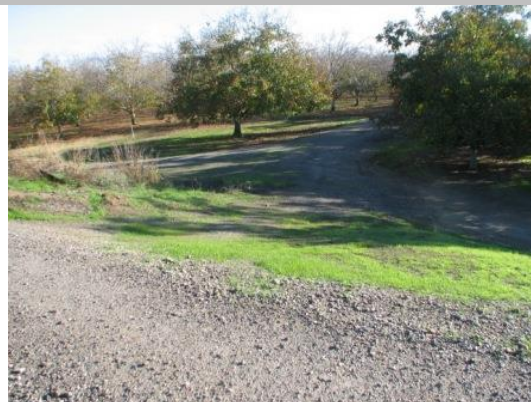
Photo 1 of 1 : SP_2018_LD0003_27_14_20180305_00012.jpg

LM Start	7.21	Rating **	M	Issue No.	14
LM End	7.21	Issue Type +	Ma	Location *	LS
Category	Earthen Levee			GPS Latitude/Longitude	
				Start	End
Item	Slope Stability			39.471658 °	39.471658 °
				-121.991245 °	-121.991245 °
DWR ID	DWR_LD0003_01_s_2012_14				
Comment Code					
S3 : Repair the levee slope damaged by vehicle traffic and prevent access where possible.					
Inspector Comment

View of the vehicle erosion along the landside slope.

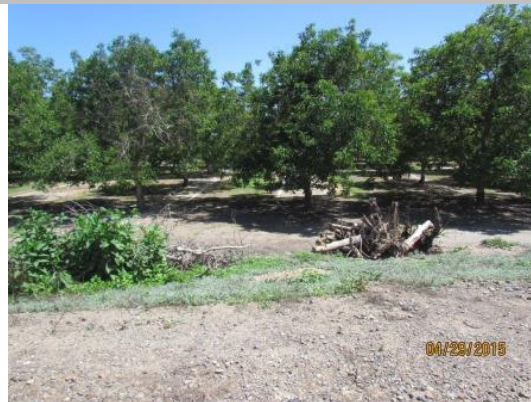
Photo 1 of 1 : SP_2018_LD0003_27_37_20180305_00020.jpg

LM Start	7.36	Rating **	M	Issue No.	37
LM End	7.36	Issue Type +	Ma	Location *	LS
Category	Earthen Levee			GPS Latitude/Longitude	
				Start	End
Item	Encroachments			39.473793 °	39.473793 °
				-121.991208 °	-121.991208 °
DWR ID	DWR_LD0003_01_s_2012_37				
Comment Code					
PR : Prunings					
Inspector Comment					
Remove the prunings from the landside slope.

View of the prunings along the landside slope.

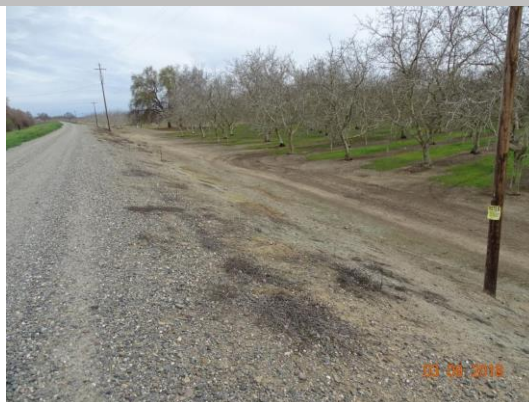
Photo 1 of 1 : SP_2018_LD0003_27_78_20180312_00111.jpg

LM Start	9.23	Rating **	U	Issue No.	78
LM End	9.31	Issue Type +	Ma	Location *	LS
Category	Earthen Levee			GPS Latitude/Longitude	
				Start	End
Item	Animal Control			39.498897 °	39.500068 °
				-121.986827 °	-121.986215 °
DWR ID	DWR_LD0003_01_f_2015_78				
Comment Code					
A1 : Exterminate rodents and backfill and compact or grout burrows.					
Inspector Comment					
Repair the rodent holes along the landside slope.

View of the rodent holes along the landside slope.

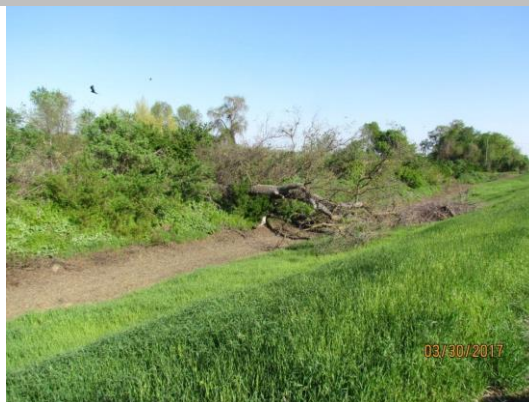
Photo 1 of 1 : SP_2018_LD0003_27_49_20180305_00026.jpg

LM Start	9.29	Rating **	M	Issue No.	49
LM End	9.29	Issue Type +	Ma	Location *	WS
Category	Earthen Levee			GPS Latitude/Longitude	
				Start	End
Item	Encroachments			39.499720 °	39.499720 °
				-121.986497 °	-121.986497 °
DWR ID	DWR_LD0003_01_s_2017_49				
Comment Code					
TR : Tree or limb					
Inspector Comment					
Remove the tree from the waterside slope and toe.

View of the tree along the waterside slope and toe.

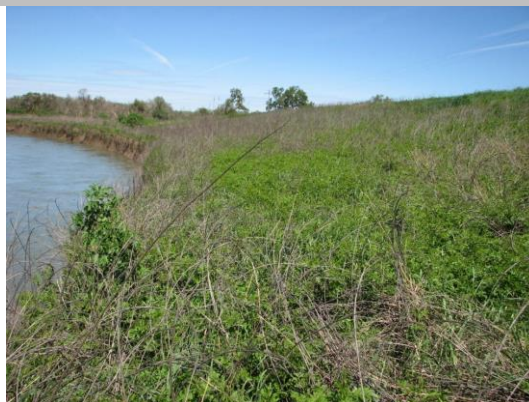
Photo 3 of 6 : SP_2018_LD0003_27_50_20180305_00029.jpg

View of erosion along the waterside toe. Same site as the USACE erosion issue. Photo 3/25/2016

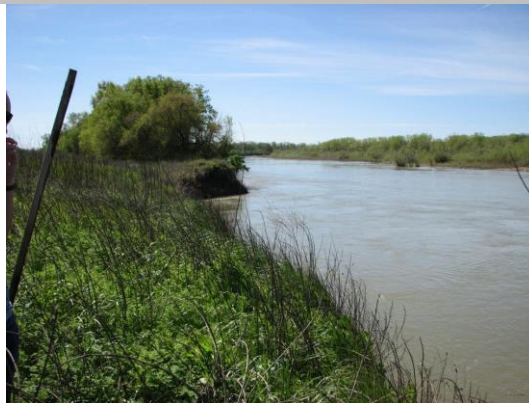
Photo 4 of 6 : SP_2018_LD0003_27_50_20180305_00030.jpg

LM Start	9.70	Rating **	U	Issue No.	50 (cont)
LM End	9.70	Issue Type +	Ma	Location *	WS
Category	Earthen Levee			GPS Latitude/Longitude	
				Start	End
Item	Erosion / Bank Caving			39.505435 °	39.505435 °
				-121.984172 °	-121.984172 °
DWR ID	DWR_LD0003_01_f_2014_50				
Comment Code					
E2 : Schedule repair of erosion site prior to the next inspection.					
Inspector Comment					
Repair the erosion along the waterside toe. On 3/25/2016, recent high water caused river to erode to within 10-20 feet of levee toe. Appears still somewhat active.

View of erosion along the waterside toe, downstream. Same site as the USACE erosion issue. Photo 3/25/2016

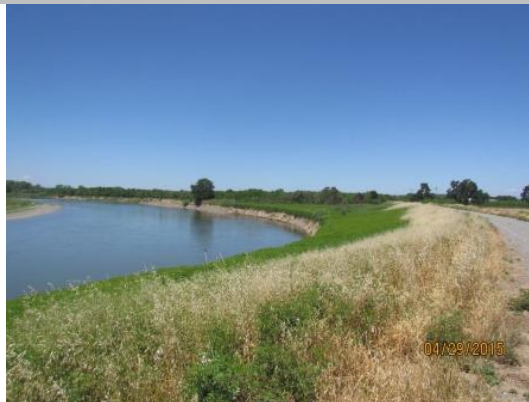
Photo 5 of 6 : SP_2018_LD0003_27_50_20180305_00031.jpg

View of erosion along the waterside toe. Same site as the USACE erosion issue.

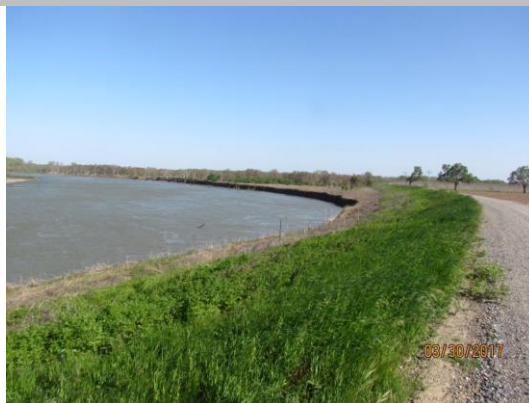
Photo 6 of 6 : SP_2018_LD0003_27_50_20180305_00032.jpg

LM Start	9.70	Rating **	U	Issue No.	50 (cont)	
LM End	9.70	Issue Type +	Ma	Location *	WS	
Category	Earthen Levee			GPS Latitude/Longitude		
				Start		End
Item	Erosion / Bank Caving			39.505435 °		39.505435 °
				-121.984172 °		-121.984172 °
DWR ID	DWR_LD0003_01_f_2014_50					
Comment Code						
E2 : Schedule repair of erosion site prior to the next inspection.						
Inspector Comment						
Repair the erosion along the waterside toe. On 3/25/2016, recent high water caused river to erode to within 10-20 feet of levee toe. Appears still somewhat active.

View of the erosion along the waterside toe. Same site as the USACE erosion issue.

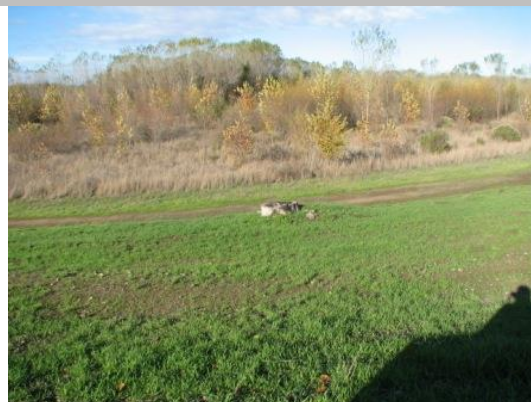
Photo 1 of 1 : SP_2018_LD0003_27_29_20180305_00016.jpg

View of the stump along the toe.

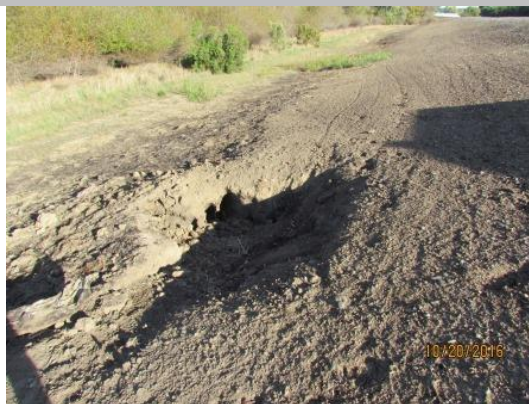
Photo 1 of 1 : SP_2018_LD0003_27_89_20180305_00057.jpg

LM Start	10.66	Rating **	U	Issue No.	89
LM End	10.66	Issue Type +	Ma	Location *	WS
Category	Earthen Levee			GPS Latitude/Longitude	
				Start	End
Item	Slope Stability			39.517553 °	39.517553 °
				-121.979132 °	-121.979132 °
DWR ID	DWR_LD0003_01_f_2016_89				
Comment Code					
S1 : Repair slope instability.					
Inspector Comment

View of a hole along the waterside slope that need to be backfilled and compacted.

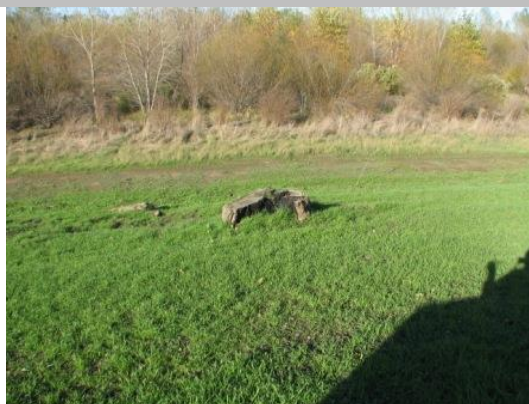
Photo 1 of 1 : SP_2018_LD0003_27_30_20180305_00017.jpg

View of the stump along the slope.
